# Home Inspection Report

**Property:** 1 ABC Drive Lekki Lagos

**Client:** ABC Realtors

**Date:** 05 September 2025

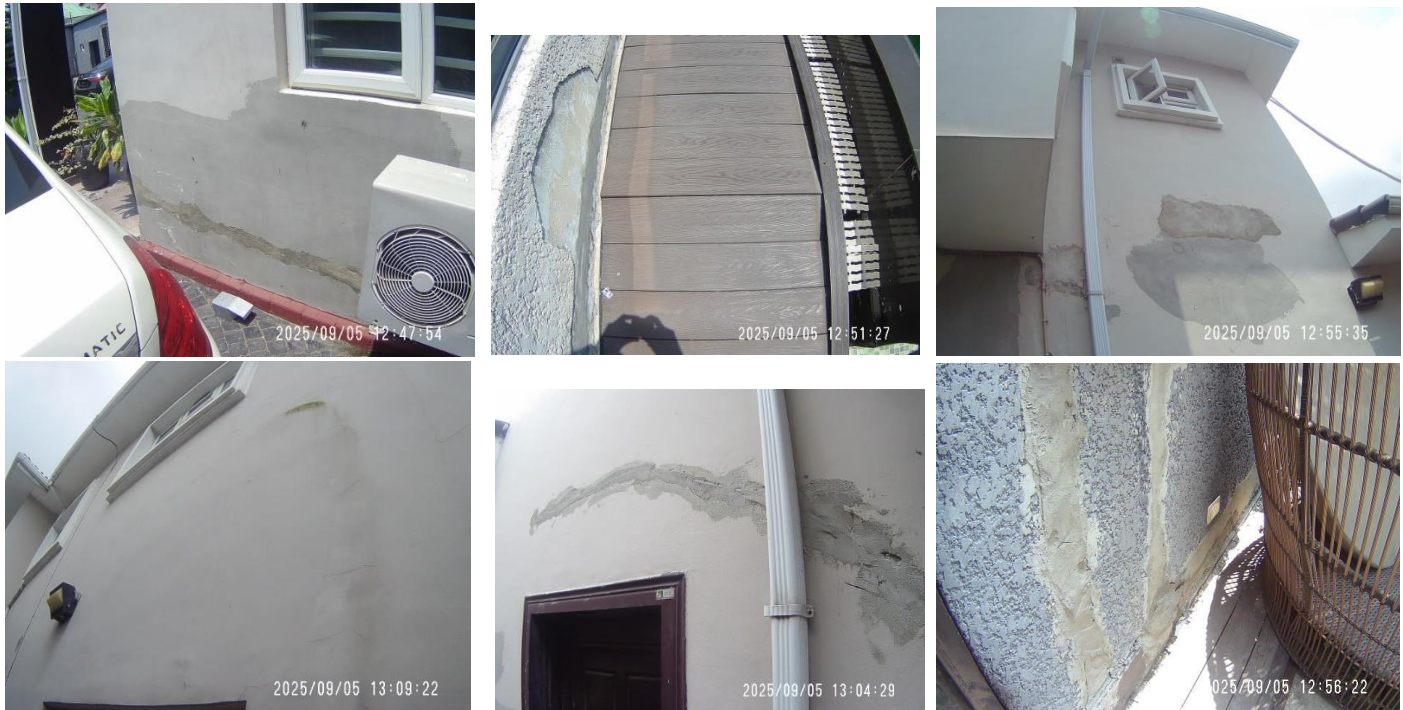
- **Walls:** Notable hairline cracks, improperly finished repair work, and peeling wall finish, were observed on exterior wall surfaces (low severity, for improved aesthetics). Below are a few related pictures:

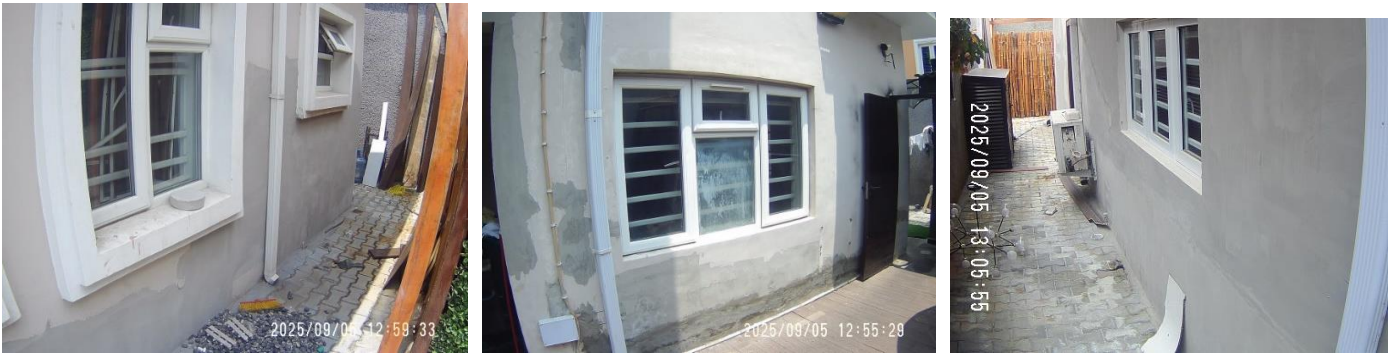
- **Foundation:** Evidence of past repairs covering suspected rising damp was noted at the base of the exterior walls (severe moisture concern for the foundation).

Component/Area	Issue Description	Recommended Action	Professional to Contact
<b>Foundation &amp; Damp Proofing</b>	Evidence of rising damp despite prior repair ( <b>Severe</b> ).	Recommend thorough assessment of foundation moisture ingress and installation of proper damp-proofing or drainage solutions.	Structural engineer / Waterproofing specialist
<b>Site Drainage</b>	Roof runoff discharges at foundation; open drains present ( <b>Severe</b> ).	Recommend installing gutters/downspouts to direct water away from the foundation and enclosing drainage channels for proper water diversion.	Roofer / Drainage specialist
<b>Gutters &amp; Downspouts</b>	Downspouts dumping water near foundation ( <b>Severe</b> ).	Extend or redirect downspouts to discharge at a safe distance from the foundation or into proper drain lines.	Roofer / Gutter installer
<b>Load-Bearing Walls</b>	Damp ingress observed in walls ( <b>Moderate</b> ).	Investigate and repair the moisture source; (repair work seen to be done).	Waterproofing specialist / General contractor

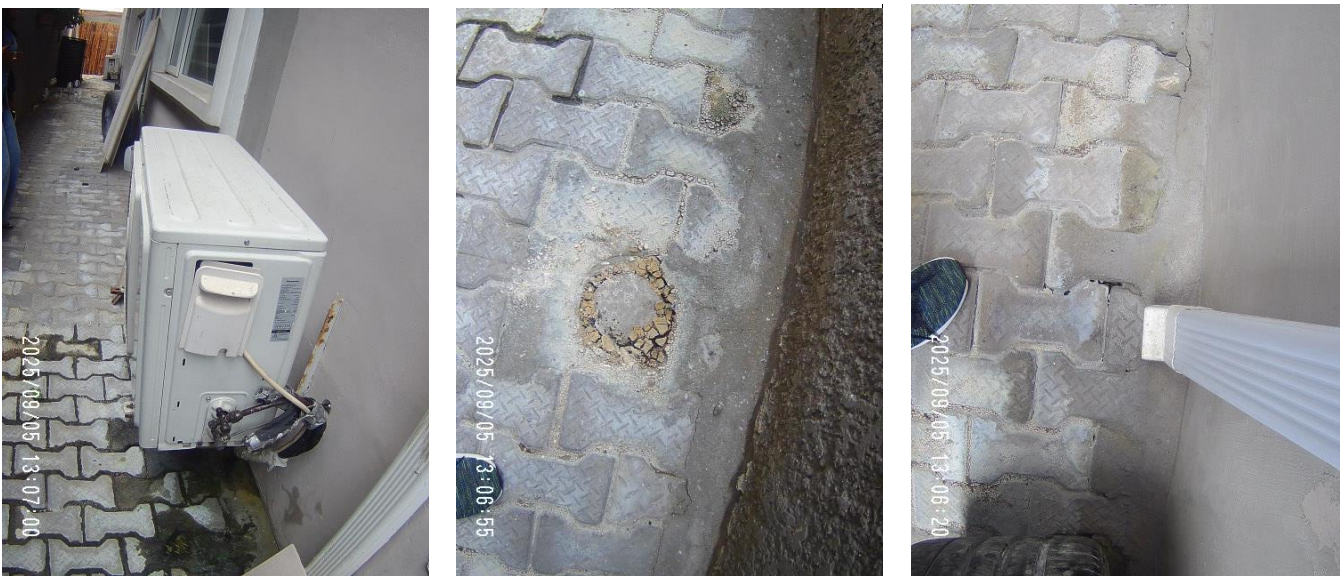
- **Drainage:** Roof drainage is inadequate – rainwater from the roof is discharging near the foundation, and the back walkway is not properly sloped to drain water away (severe water management issue).

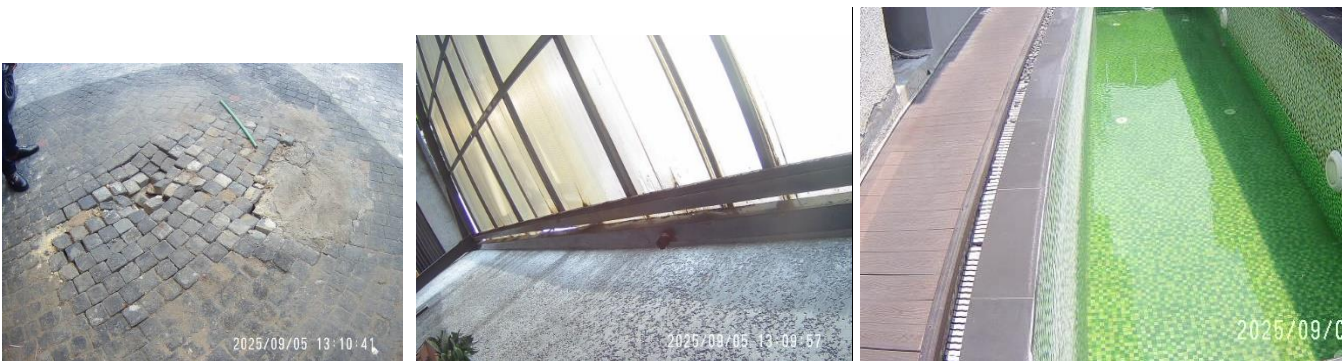
- **Driveway/Walkways/Carport:** The driveway was in need of light repair, the carport was rusted and in need of anti-rust treatment. The walkway by the pool is too narrow (low severity but functional).

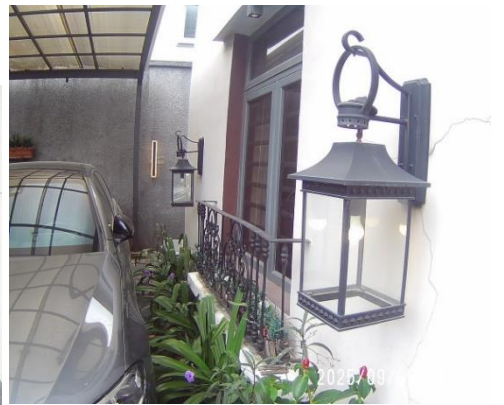
- **Exterior Lighting:** Lighting is installed around the exterior; a few fixtures are defective and will need repair or replacement for full coverage.

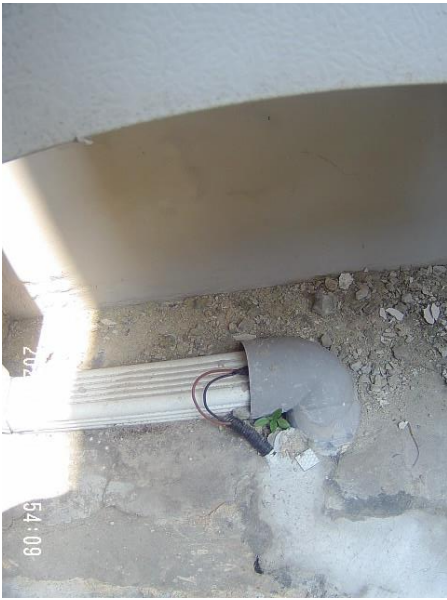
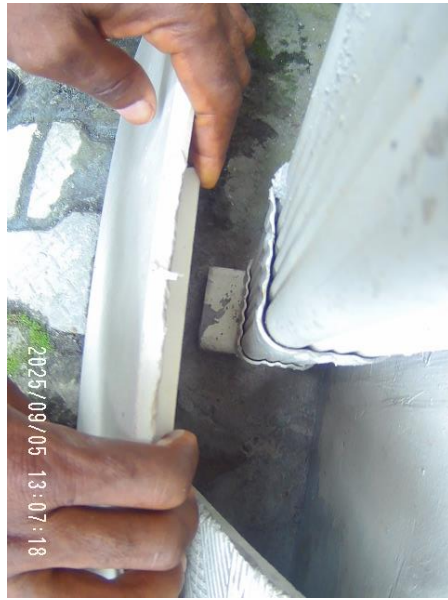
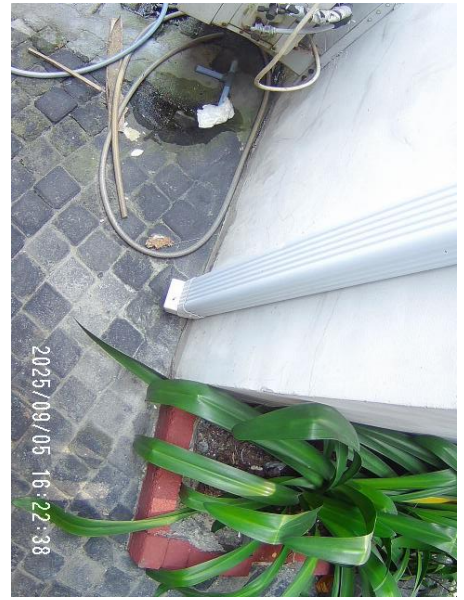
- **Gutters/Downspouts:** Gutters are installed along roof edges, but most downspouts discharge too close to the building foundation, contributing to moisture around the structure, also one drain pipe had wires going through it, which is a shock hazard (severe concern – see Drainage issue above).

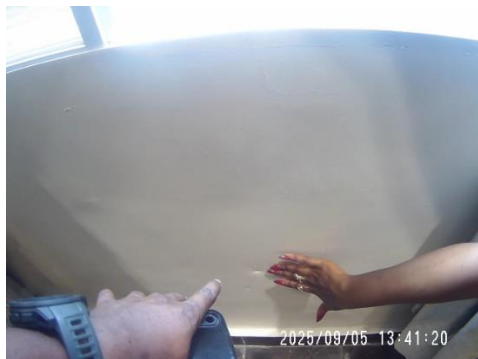
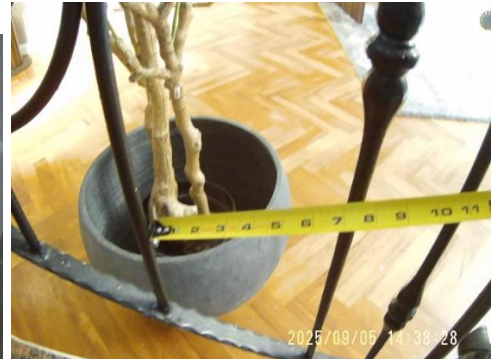
- **Handrails:** Stair and balcony handrails are at an acceptable height (~1m) and firmly anchored. Baluster spacing is mostly under 10cm, though one decorative opening slightly exceeds that (minor child-safety note).

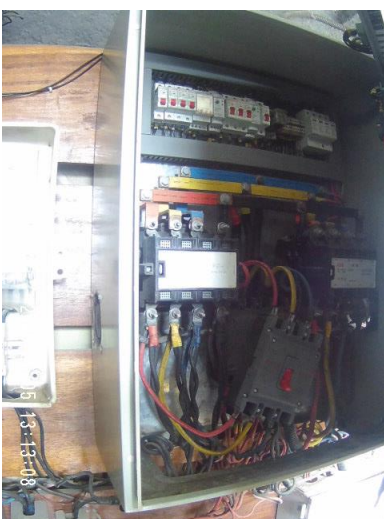
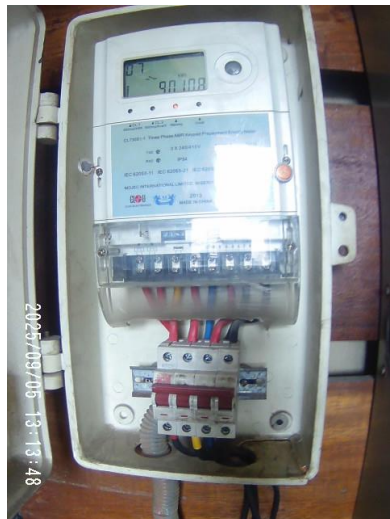
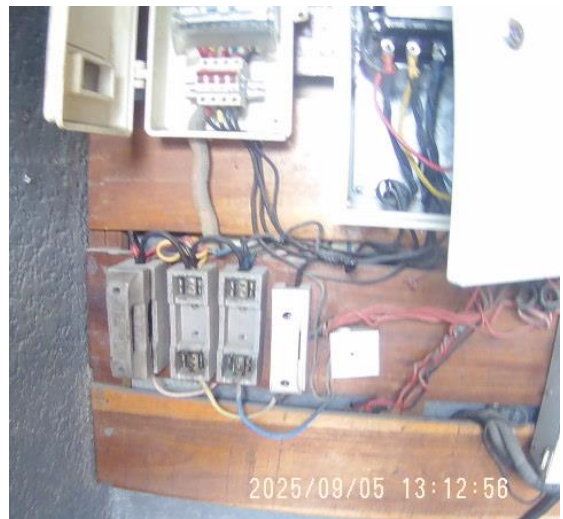
- **Service Entry:** The main electrical service/meter is in place but the installation is not ideal. The meter box is secure but open, other components appear to be functional but general installations and conditions are less than ideal. (moderate issue, recommend evaluation).

<b>Electrical Service Entry/Meter/Surge Protection</b>	Installation not up to standard. And lights don't work ( <b>Moderate</b> ).	Have the service entry, Surge protector and other devices corrected to meet safety standards (secure mounting, proper enclosure & labeling). Fix lights.	Licensed electrician
<b>Main Distribution Board</b>	Missing RCD (safety breaker) and labels; mounted too high or out of reach; Open breaker slots. ( <b>Moderate</b> ).	Install appropriate circuit breakers (MCB) and a residual current device (RCD) for safety, label all circuits, and reposition or modify the board for safe access.	Licensed electrician
<b>Electrical Earthing</b>	Inadequate grounding of electrical system ( <b>Severe</b> ).	Install or repair the grounding electrode/system and bond all metal components to ensure proper electrical safety.	Licensed electrician
<b>Internal Wiring</b>	Exposed electrical wires noted. Suspected load imbalance ( <b>Moderate</b> ).	Enclose or reroute exposed wiring in conduits; repair any unsafe electrical connections, and also balance the load to meet code.	Licensed electrician

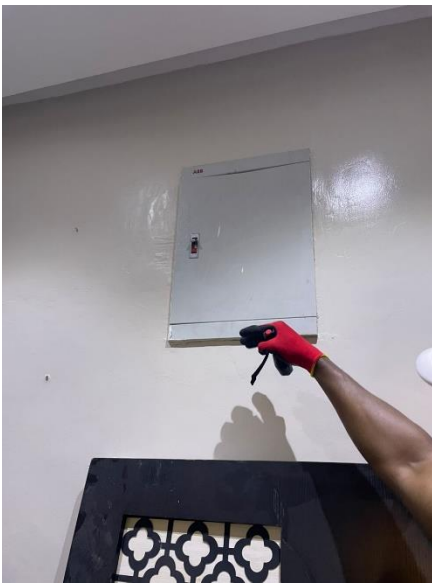
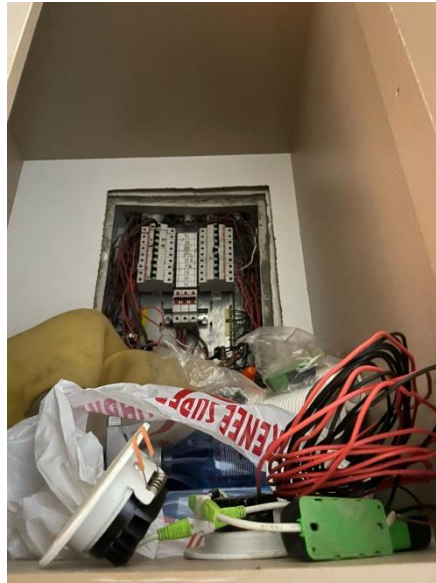
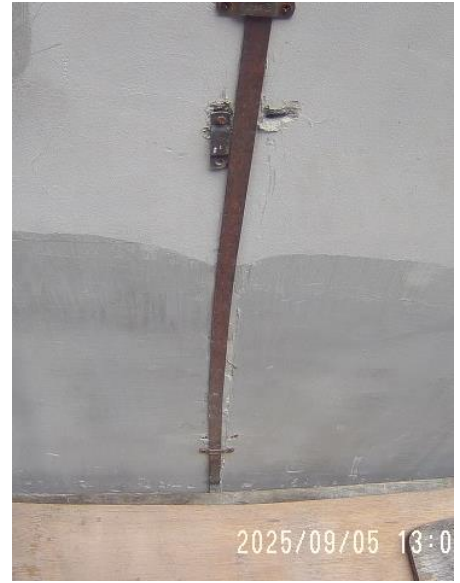
- **Main Panel (Distribution Board):** The main distribution board is functioning but lacks a Residual Current Device (RCD/GFCI) for wet-area circuit protection. All circuit breakers were unlabeled and

some breaker slots were open/uncovered (moderate safety issue). The panel is also mounted higher than convenient for access, with one within a narrow wooden cabinet surrounded by flammables and without cover.

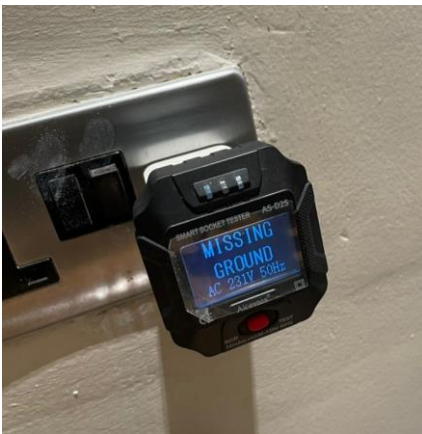
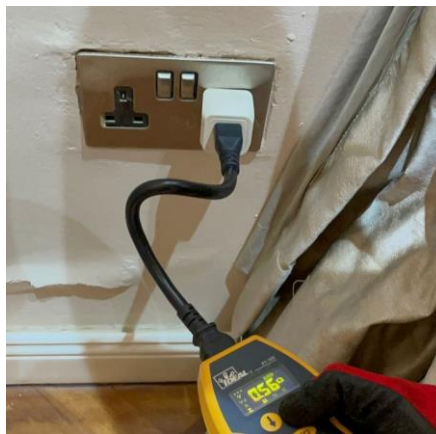
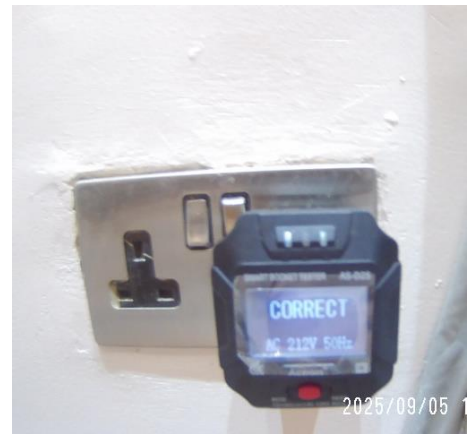
- **Grounding (Earthing):** The home's electrical grounding is inadequate (severe safety concern). The grounding / earthing system need improvement to ensure the system is safely earthed.

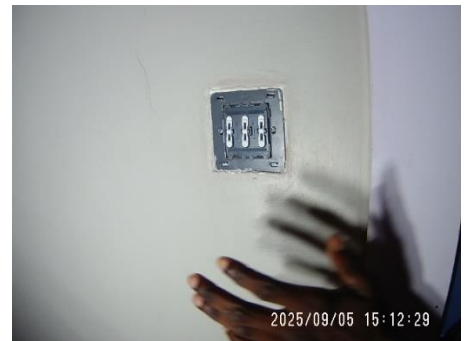
- **Outlets/Switches:** The outlets and switches are generally secure and showed only a couple burn signs marks or overheating. A few had loose or missing cover plates or were poorly installed (minor maintenance issue, easy fix).

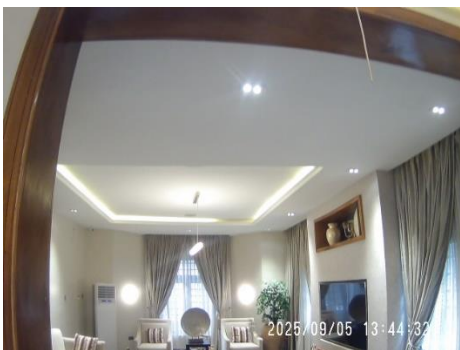
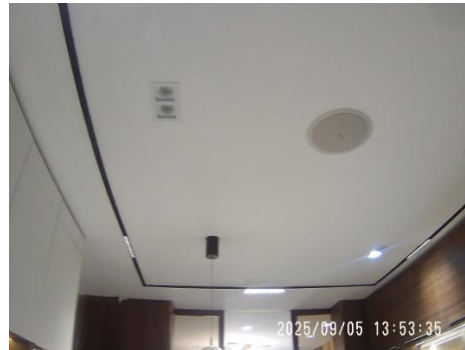
- **Lighting:** Most light fixtures (indoor and outdoor) were operational. However, fixtures in wet areas (bathrooms, exterior) are not the moisture-resistant type and a few lights were not working (low concern for upgrade).

<b>Lighting Fixtures</b>	No wet-rated fixtures in bathrooms open/loose outlets in some; Also some lights not working ( <b>Moderate</b> ).	Replace non-waterproof switches/fixtures in wet areas with rated units; repair or replace defective light fixtures. Cover open outlets.	Licensed electrician
<b>Interior Walls</b>	Efflorescence build up, and peeling paint at	Address moisture intrusion (likely rising damp); apply appropriate	Waterproofing specialist / Painter

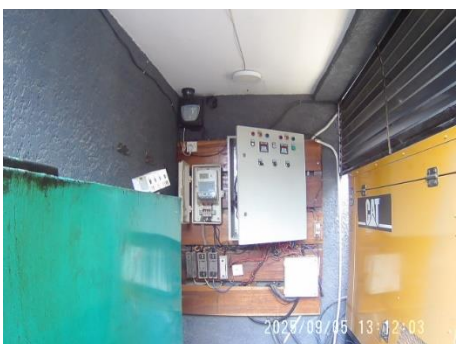
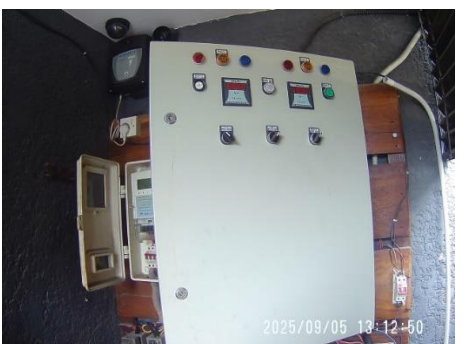
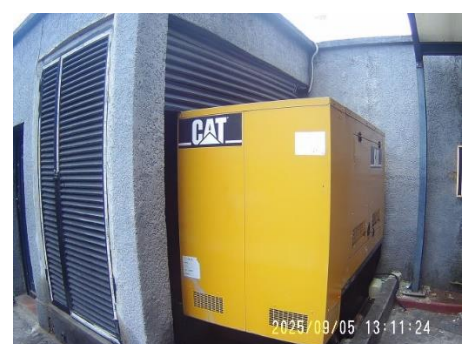
- **Backup Power:** A generator is on-site and was partially tested – it started and ran with normal sound and exhaust. The generator is partially enclosed leaving most parts of it exposed to the elements (adequate ventilation observed). There is also an inverter system installed, though it was not tested during this standard inspection.
- **Surge Protection:** A surge protector device was noted at the main panel for whole-house protection. But didn't seem to be installed or maintained professionally.

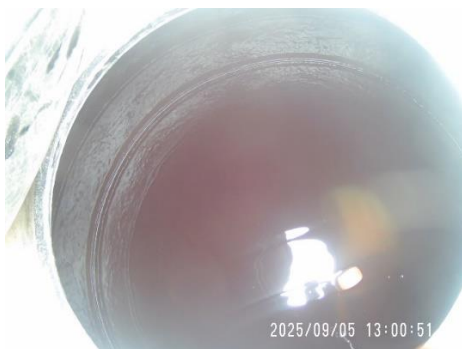
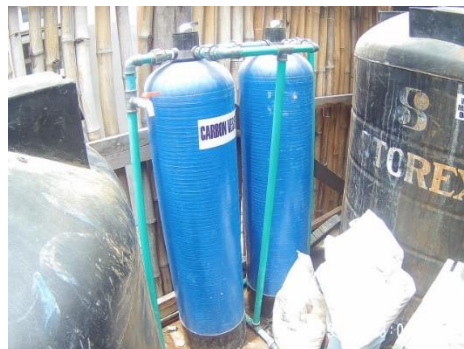
- **Outdoor Plumbing:** One outdoor tap is missing and was leaking when tested. Additionally, exterior taps do not have catch basins.
- **Treatment System:** The water treatment/filtration system is installed and operational.
