# Home Inspection Report

**Property:** 1 ABC Drive Lekki Lagos

**Client:** ABC Realtors

**Date:** 05 September 2025

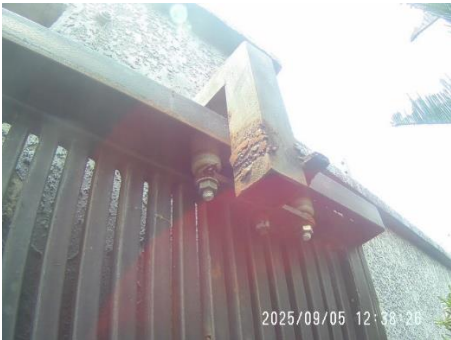
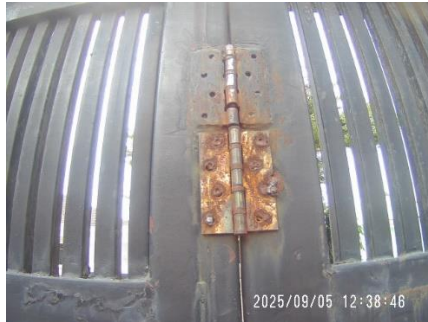
- **Fence/Gate:** The perimeter fence appears sound and plumb. The gate shows light rust, and the pedestrian gate hinges are somewhat weak (low severity, but functional).

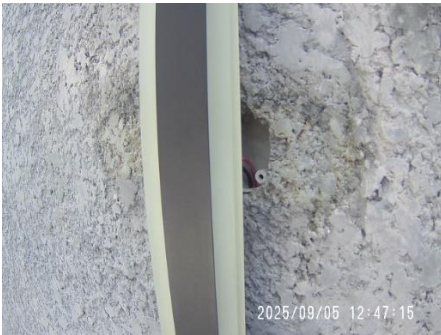
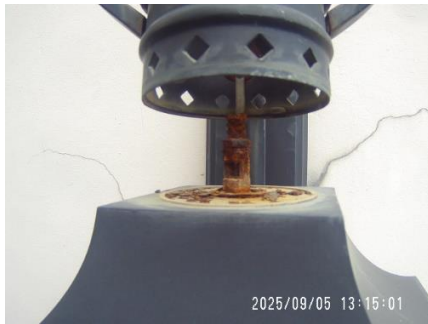
- **Exterior Lighting:** Lighting is installed around the exterior; a few fixtures are defective and will need repair or replacement for full coverage.

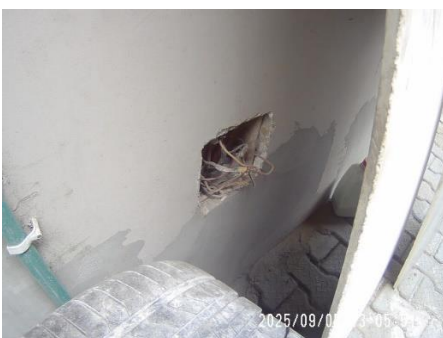
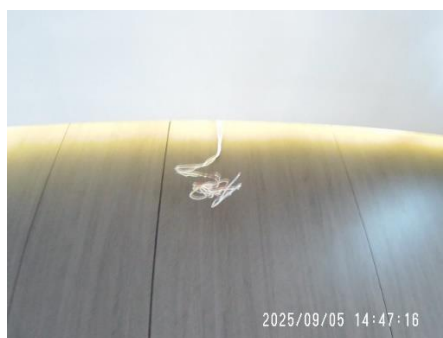
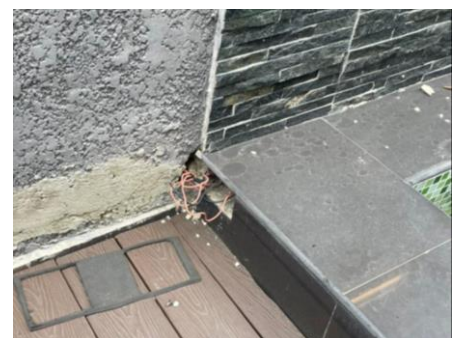
- **Internal Wiring:** Internal wiring is mostly routed through conduit/trunking and apart from a couple of outlets seem to be properly done. However, an uncomfortable number of exposed wiring were noted (e.g., above the ceiling or near fixtures) – these should be enclosed for safety (moderate issue).

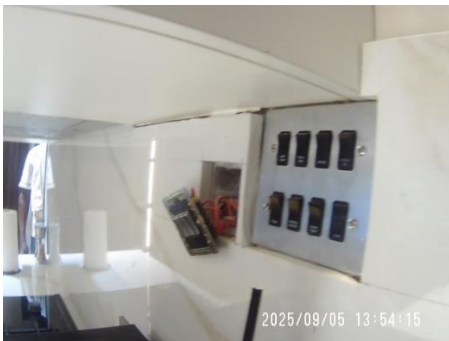
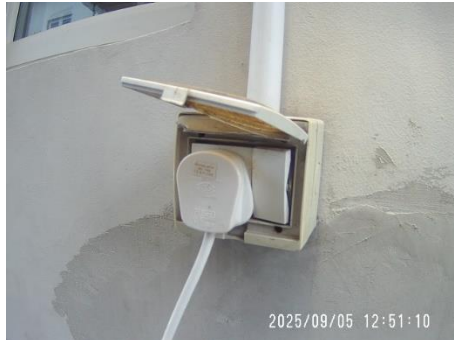
- **Outlets/Switches:** The outlets and switches are generally secure and showed only a couple burn signs marks or overheating. A few had loose or missing cover plates or were poorly installed (minor maintenance issue, easy fix).

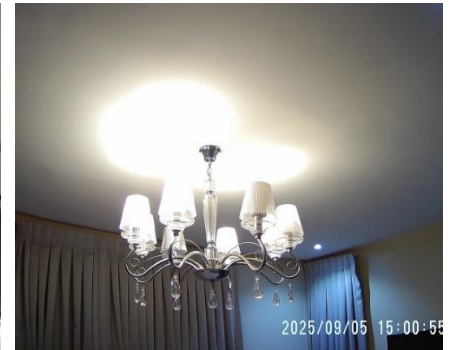
- **Lighting:** Most light fixtures (indoor and outdoor) were operational. However, fixtures in wet areas (bathrooms, exterior) are not the moisture-resistant type and a few lights were not working (low concern for upgrade).

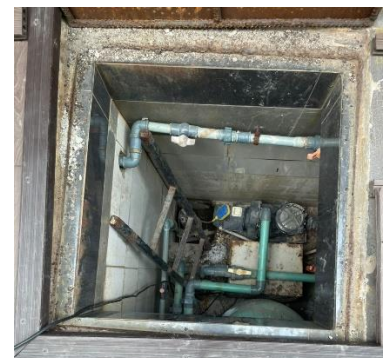
- **Outdoor Plumbing:** One outdoor tap is missing and was leaking when tested. Additionally, exterior taps do not have catch basins.
- **Treatment System:** The water treatment/filtration system is installed and operational.

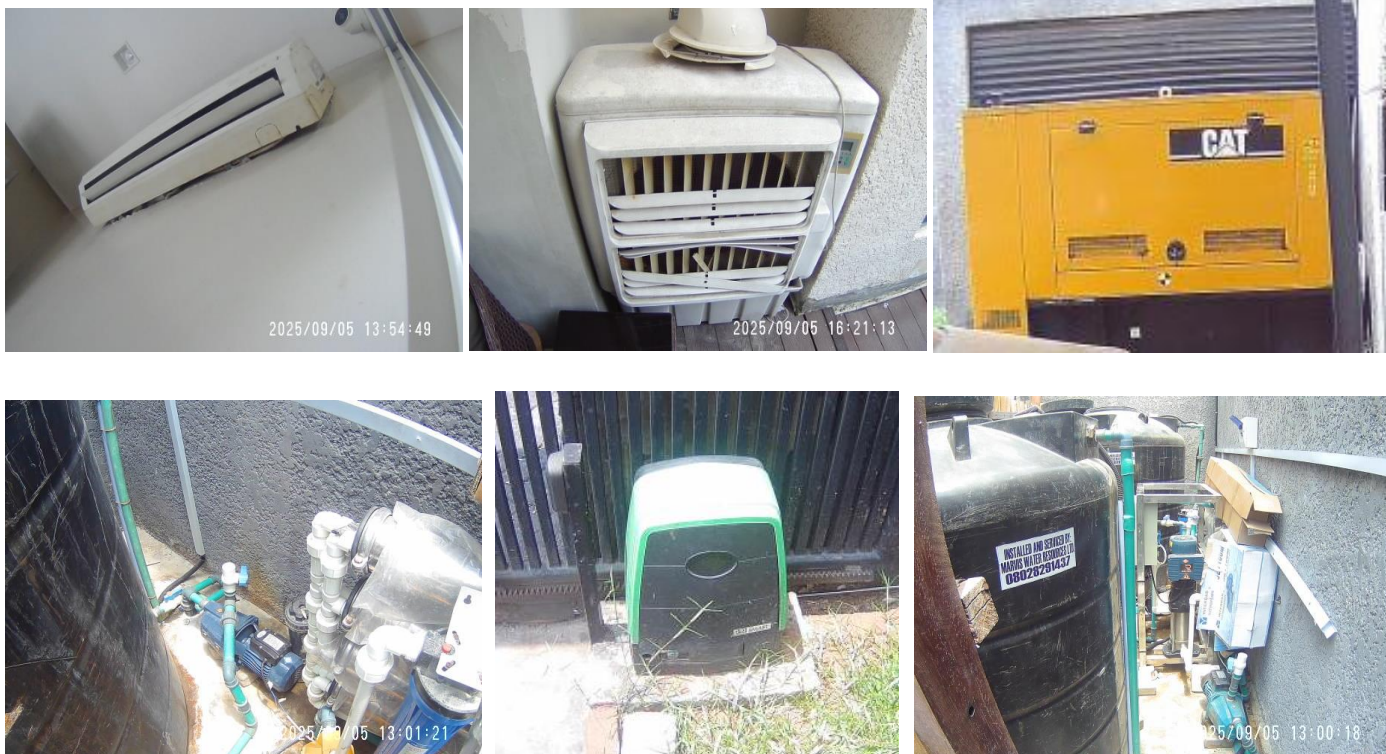
- **Air Conditioning:** Split and standing air-conditioning units (where installed) were tested and found to be cooling effectively. They ran quietly with no vibrations, and no indoor water drips were seen (condensate draining properly, but close to the foundation). Outdoor condenser units are stable on their mounts and free of debris.

- **Ceiling Fans:** None Installed.
- **Exhaust Fans:** The kitchen's exhaust hood fan did work and appears faulty (should be repaired for proper kitchen ventilation). Bathroom exhaust fans were tested– most drew air moderately except the guest toilet fan, which did not turn on (needs repair or replacement).

- **Inverter/Battery Backup:** An inverter system with battery backup is installed to provide power during outages. The system was not tested, but the inverter unit was observed and the battery bank terminals are clean and the enclosure is ventilated, however the electrical aspect of the set up needs attention.

- **Water Pump:** The water pump system engages smoothly.
- **Fire Equipment:** No fire sprinkler system or alarm system is installed (typical for a residential home). Notably, no fire extinguishers were found on site (moderate safety concern; see Safety & Security section). It is strongly recommended to add basic fire-fighting equipment.

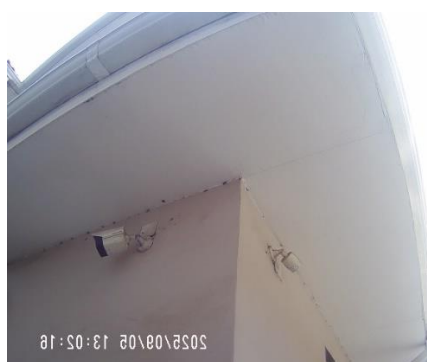
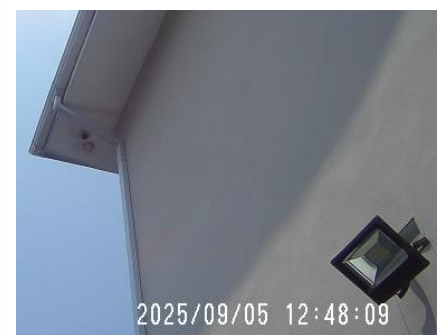
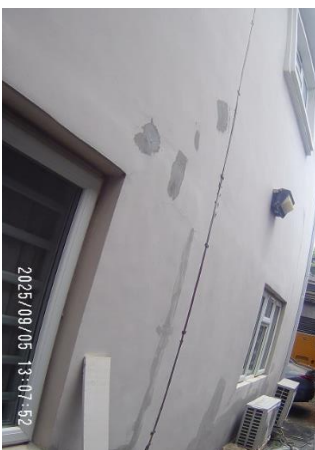
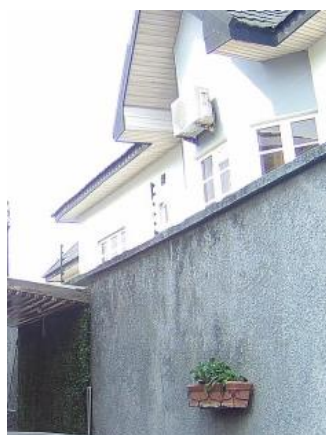
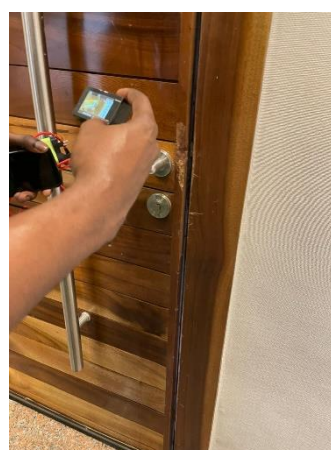
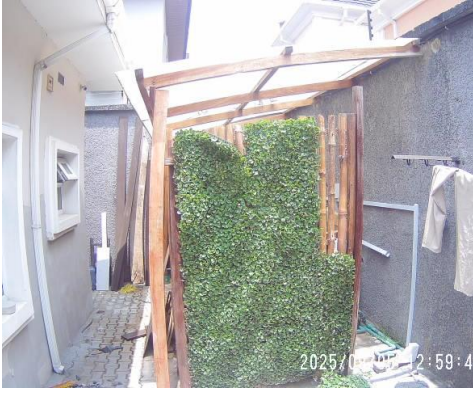
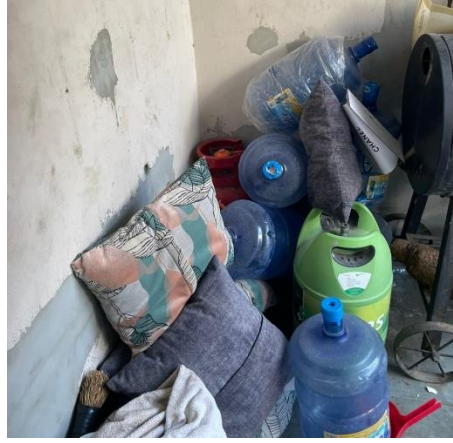
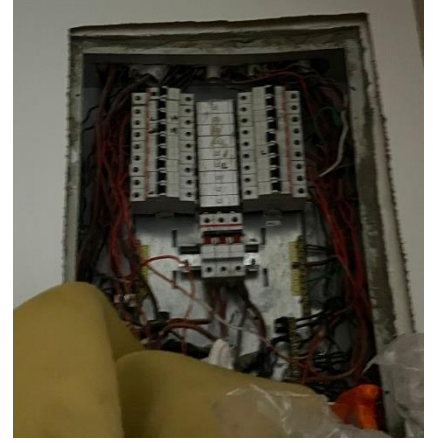
- **Main Door Security:** The main entry is a security-grade wood w/metal door. Its lockset was found to not engage (moderate security issue). This should be repaired or replaced to ensure reliable locking. Hinge screws appear secure and of proper length.

- **Window Bars/Egress:** Ground floor windows have fixed burglar bars for security. They are firmly anchored and mostly aluminum (anti rust) a steel burglary showed only minor corrosion, while one was missing some rungs. However, note that bedrooms with barred windows do not have quick-release mechanisms, which means they are not usable as emergency exits (safety consideration). It's recommended to install at least one emergency egress option upstairs.

- **Exterior Lighting:** The compound and exterior are fairly illuminated by wall-mounted lights and flood lights. Some dark corners were noted due to a couple of non-functional fixtures.

- **Smoke Detectors:** There are **no smoke detectors** installed inside the home (moderate fire safety concern).
- **Fire Extinguishers:** No fire extinguishers or fire blankets were found (moderate fire preparedness issue). At minimum, an ABC-rated fire extinguisher should be mounted on each floor.

- **Electrical Protection:** The home lacks Ground-Fault Circuit Interrupter (GFCI) protection in wet areas (bathrooms, kitchen). This is a moderate electrical safety improvement that is recommended – GFCI outlets or breakers greatly reduce shock hazards near water. Also the Earthing system needs an upgrade. A thunder arrestor seemed to be installed at the time of inspection.

- **Gas Safety:** The home uses cooking gas, the cylinder is located outside with current setup incorrect as it's crowded with flammable items. The gas hose and regulator looked to be in good condition with no leaks detected at the time.

- **Emergency Egress:** Aside from the main and rear entrances, there are limited emergency exits due to barred windows. It's important that occupants have an emergency plan, and consider making one upstairs window openable or breakable in case of fire.
